NATIONAL PROGRAM FOR INSPECTION OF NON-FEDERAL DAMS
HAMILTON RESERVOIR DA. (U) CORPS OF ENGINEERS WALTHAM
MA NEW ENGLAND DIV NOV 78

20. ABSTRACT (Continue on reverse side if necessary and identify by block number) The dam is an earthfill embankment and concrete spillway dam. It is about 100 ft. long and has a maximum height of 17 ft. The project is considered to be in good condition. It is intermediate in size with a significant hazard potential.. It is recommended that the owner retain a competent con- sulting engineer to conduct further studies to determine the measures that are necessary to improve the discharge capacities.

VICINITY MAP
HAMILTON RESERVOIR DAM

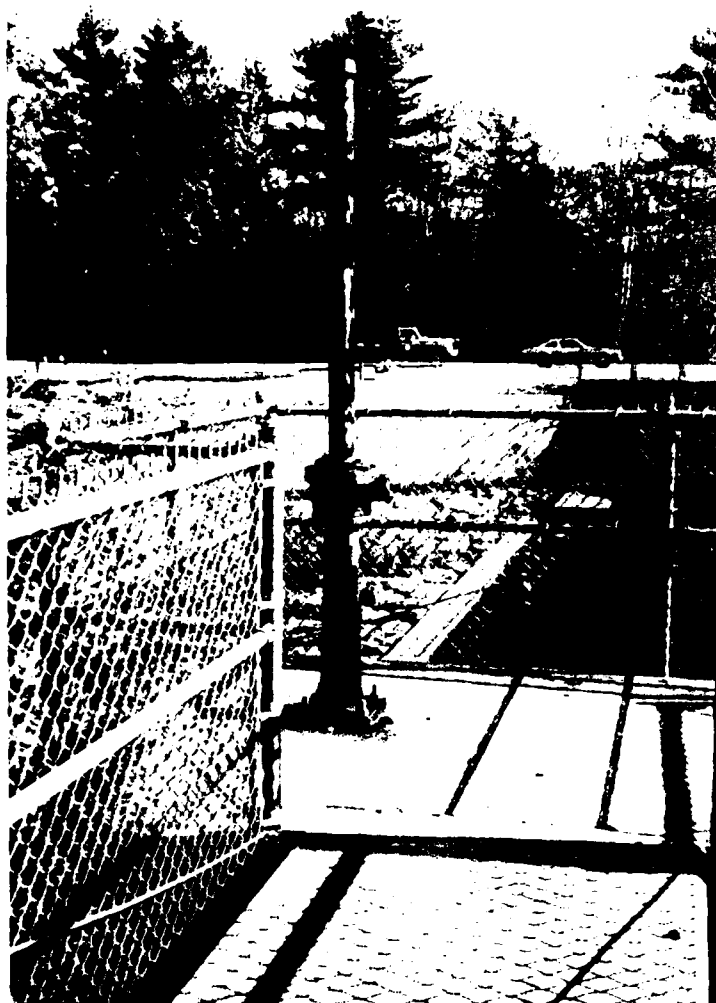
The intake structure is in good condition, the concrete is sound and free of spalled areas. There was no debris, other than some leaves observed at the trash rack. The operating stand is in good condition. (See Photograph No. 10). The operating handle was not in place, but reportedly is kept at the Public Works Dept. At the time of the inspection, the sluice gate was operable and open about two or three inches and the discharge did not appear to be impeded. (See Photograph No. 6).

10. VIEW OF LOW LEVEL GATE OPERATING STAND.
